# Damage Characterization of EBC-SiC/SiC Ceramic Matrix Composites Under Imposed Thermal Gradient Testing

**Matthew Appleby\*, Gregory Morscher\*, Dongming Zhu†**

38th International Conference and Exposition on  
Advanced Ceramics and Composites. Daytona Beach, FL

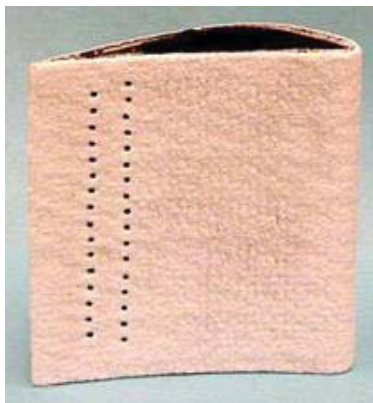
SiC/SiC vane sub-element coated with an environmental barrier coating and containing cooling holes in the trailing edge.

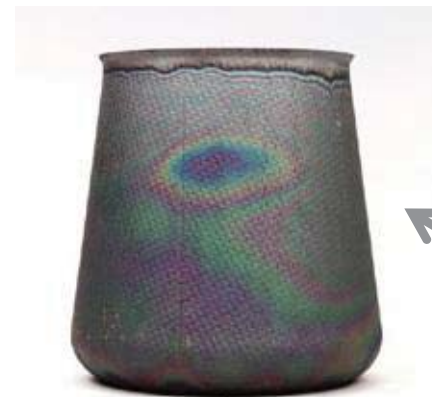
Tested SiC/SiC combustor liner from NASA's High Speed Research program
